NBSIR 82-2593

Investigation of Construction Failure of the Riley Road Interchange Ramp, East Chicago, Indiana

October 1982

N. J. Carino
H. S. Lew
W. C. Stone
R. M. Chung

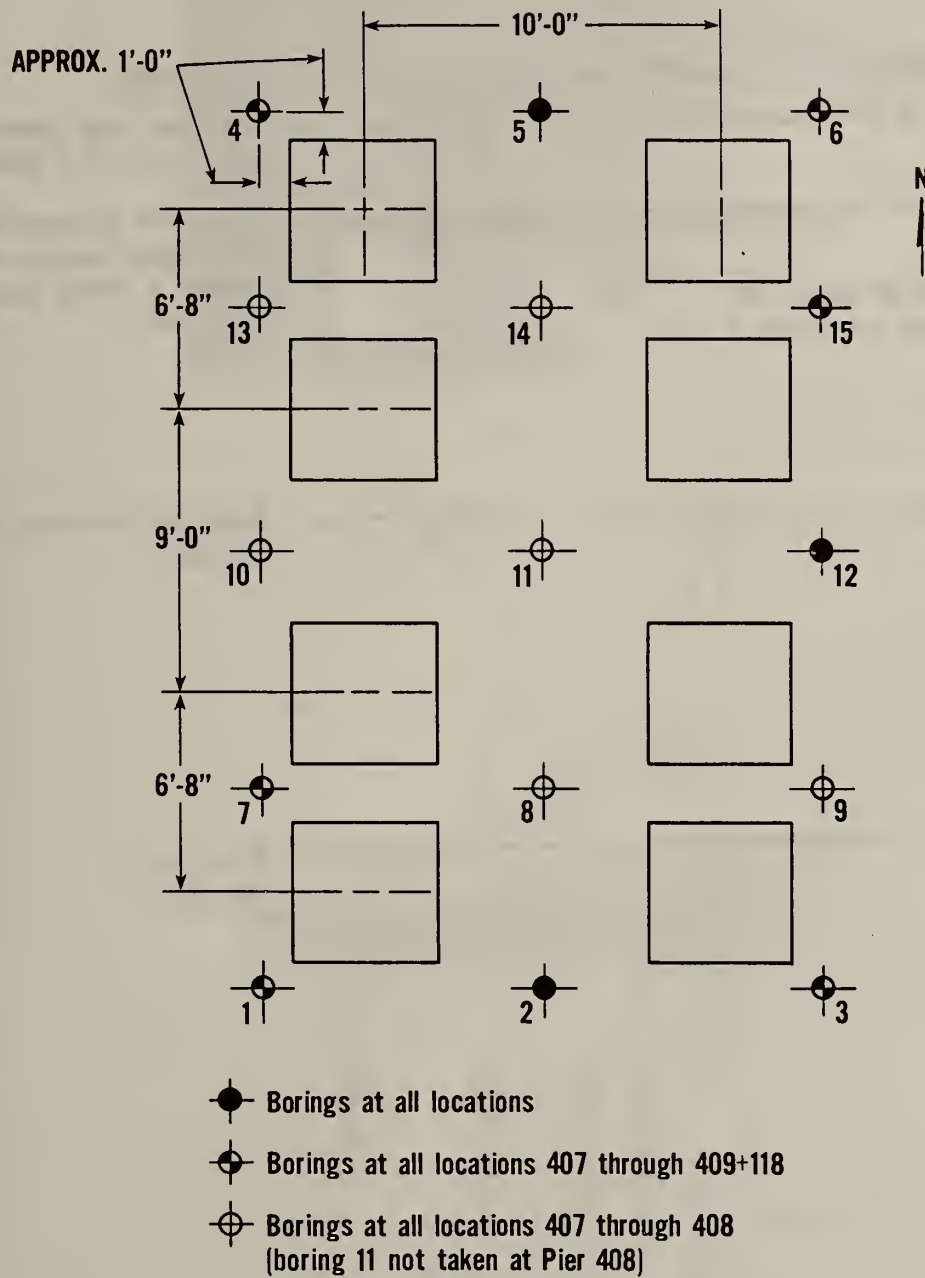
Soil test borings were made along Ramp C after some of the collapse debris had been removed, and the IOSHA provided NBS with the boring data. Soil borings were taken at each tower location from 403.2 to 409.2 as indicated in figure 3.2. In most instances, the soil test borings were 15 ft (4.6 m) deep and samples were taken at 2 ft (0.6 m) intervals using a 2-in (51-mm) outside diameter split spoon sampler. Blow counts from the Standard Penetration Test (ASTM D 1586-67 (1974)) were obtained. Other holes were bored to a depth of 25 ft (7.6 m) or 35 ft (10.7 m) with the samples taken in the same manner. The samples were placed in sealed jars and stored at the project site.

Figure 3.2 Position of soil borings at each tower location

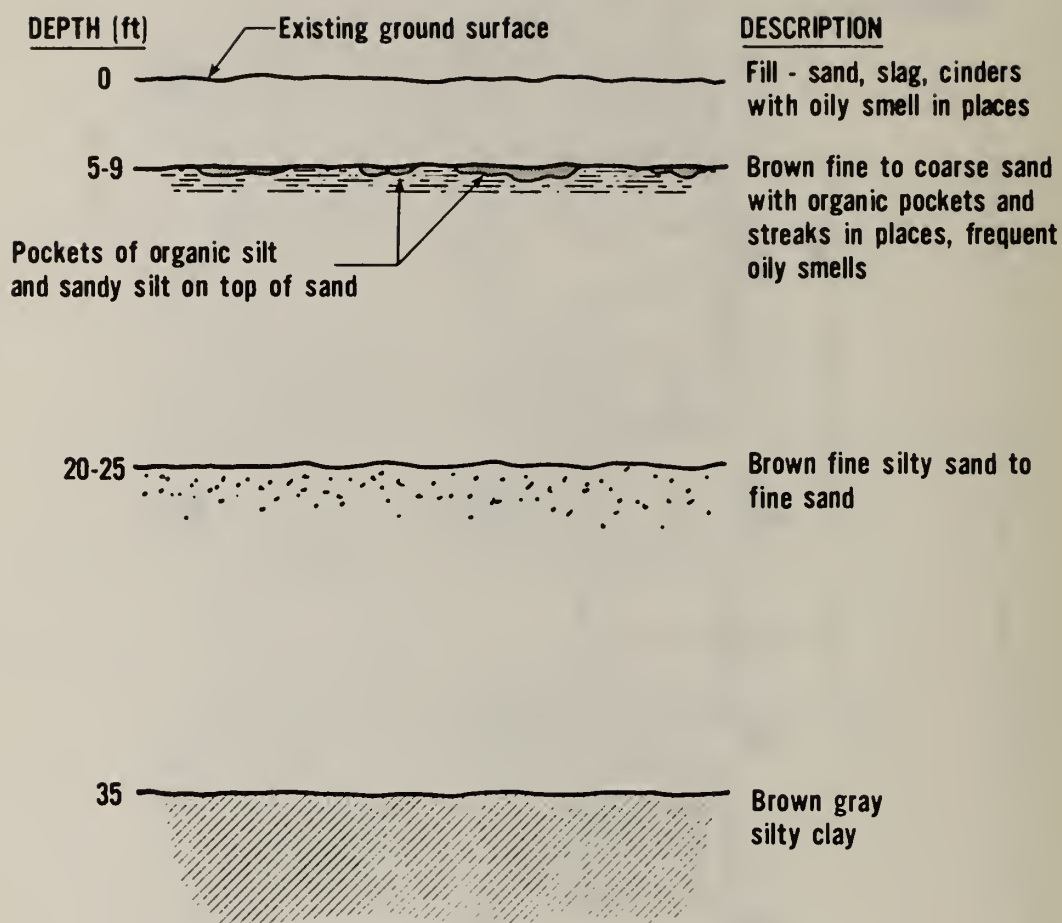
Figure 3.3 depicts the general subsoil condition derived from the sample examinations. It indicates that the ground is covered by a layer of fill 5 to 9 ft (1.5 to 2.7 m) in thickness. The fill is composed of dark brown and gray cinders and slag, sometimes mixed coarse sand and having an oily smell in places. Blow counts from the fill were scattered, and in some places refusal was marked on the field log indicating that difficulties were encountered during sampling. In some other holes, the blow counts were low (<10) indicating that the fill was loosely placed. Below the fill and to a depth of 20 to 25 ft (6.1 to 7.6 m) there is a layer of medium dense to dense brown fine to coarse sand. Pockets of saturated and highly compressible black organic silt and sandy silt, or dark brown sand with streaks of black organic material, were found just below the fill. The organic pockets were estimated to be 1 to 2 ft (0.3 to 0.6 m) in thickness and frequently had an oily smell. Below the sand layer, there is a layer of medium dense to dense brown fine silty sand to fine sand of 10 to 15-ft (3 to 4.6-m) thickness underlain by a stiff brown-gray silty clay to the depth explored.

Figure 3.3 Typical soil profile between tower locations 407.1 and 408 (except adjacent to pier 408)

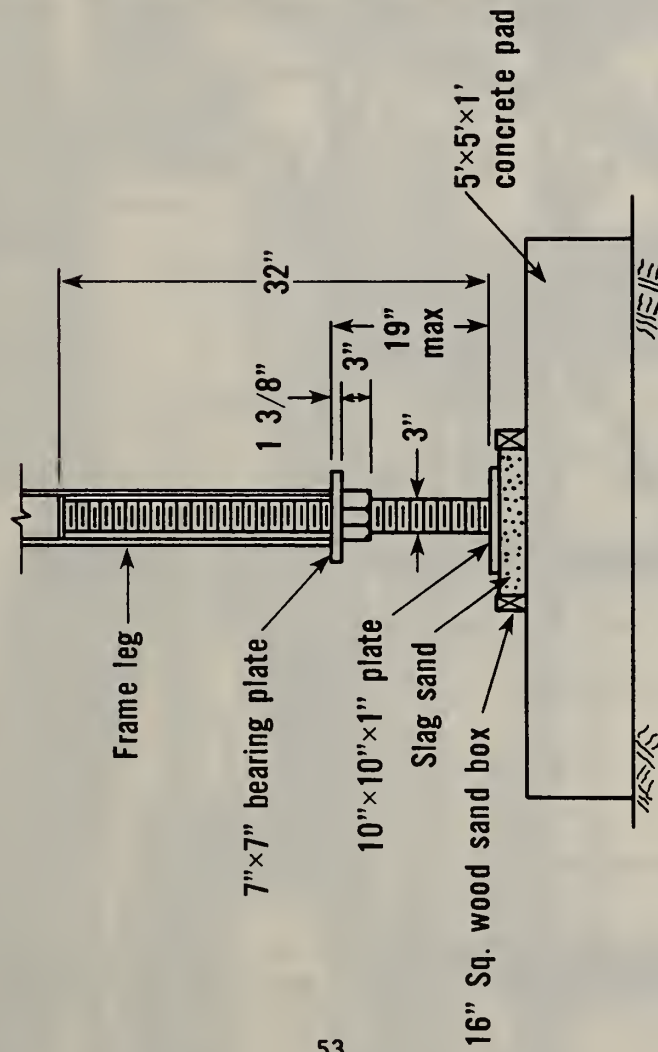
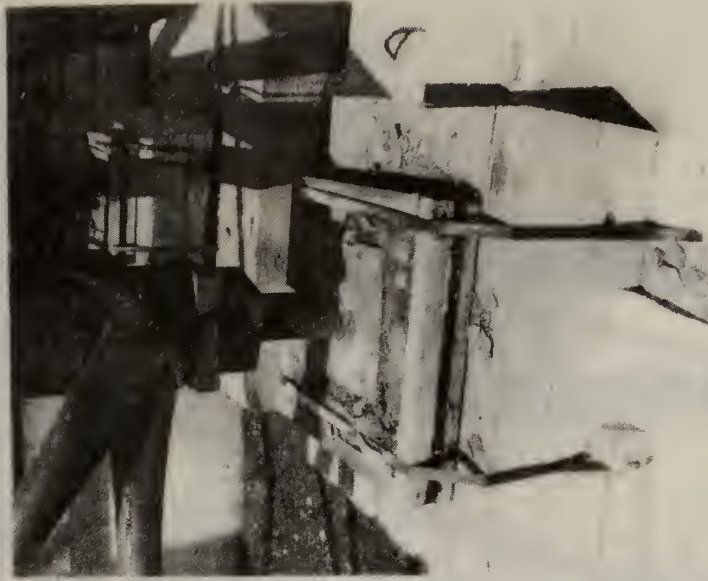
The lower screw jacks of the shoring towers did not bear directly on the concrete pads (see figure 3.4). According to the structural drawings, the jacks were to rest on circular, metal, sand boxes made of 16-in (41-mm) diameter pipe welded to a 1/4-in (6-mm) steel plate. Field inspections revealed that from tower locations 403.2 to 408.1 (N), the specified sand boxes were not used. Instead, the contractor substituted wood boxes made from ordinary 2 x 4 lumber and an aluminum sheet-metal base. Figure 3.4(b) shows a wood sand box from location 406-H. At some tower locations wood cribbing of nominal 12 x 12-in (305 x 305-mm) cross section was used beneath the boxes. The cribbing was needed to achieve the correct elevation at the top of the shoring towers.

As will be discussed in section 3.3, problems arose with the wood sand boxes and as a result metal banding, as seen in figure 3.4(b), was added as a remedial measure. Banding was reportedly used to prevent the boxes from lifting off the cribbing and to prevent the boxes from spreading laterally during loading. In cases where the sand boxes rested directly on the concrete pads, the hold down was achieved by wedging two pieces of lumber between the bearing plate and two other pieces of lumber laid across the top of the box. In the region between piers 407 and 408, it was determined that cribbing was used only at tower 407.1(S), and at the other locations the sand boxes rested directly on the concrete pads. Figure 3.5 is a view of location 407.1 as it appeared about one month before the accident. The photo was taken by an official of the Federal Highway Administration during an inspection of the construction in mid-March, 1982.

Figure 3.4 Typical support system for shoring tower leg

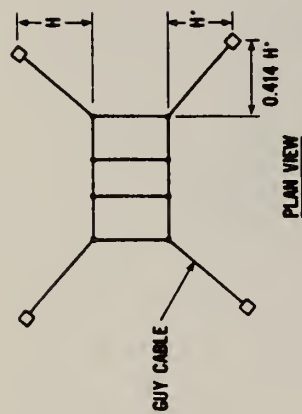
*Dimensions as shown on sheet 346 of structural drawings, these should be reversed

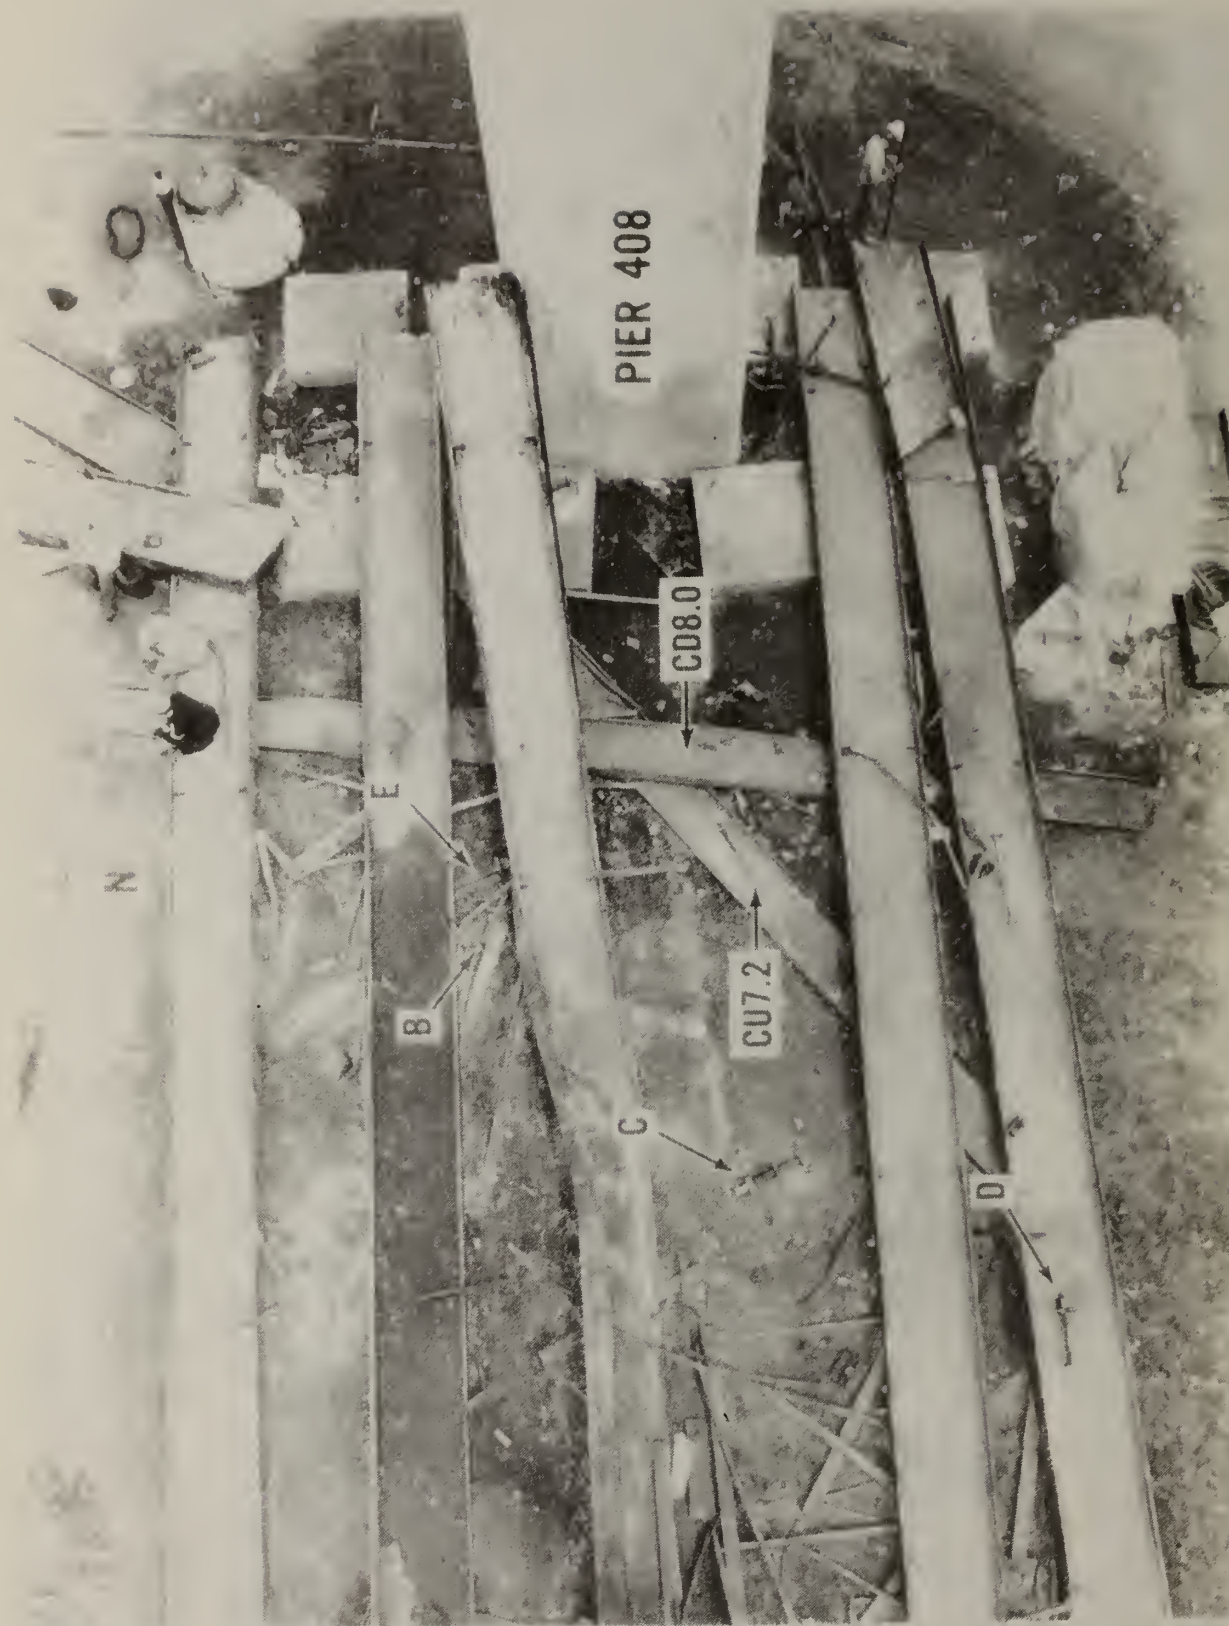
Figure 3.21 shows the positions of the four top screw jacks found in the debris, and the letters indicate to which tower leg each one belonged.

Figure 3.21 Location of top screw jacks and their probable positions in the towers at 407.2

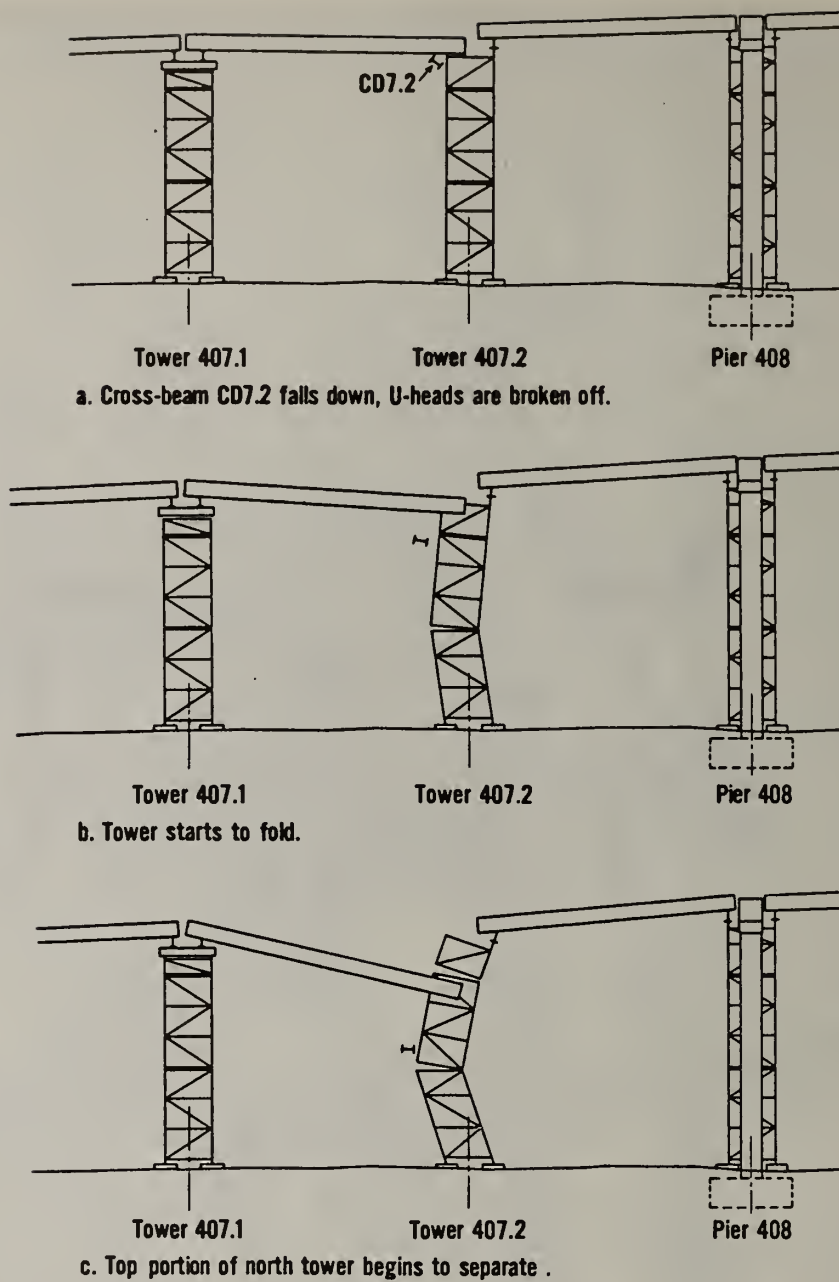
Figure 3.23 Possible collapse sequence of falsework at 407.2

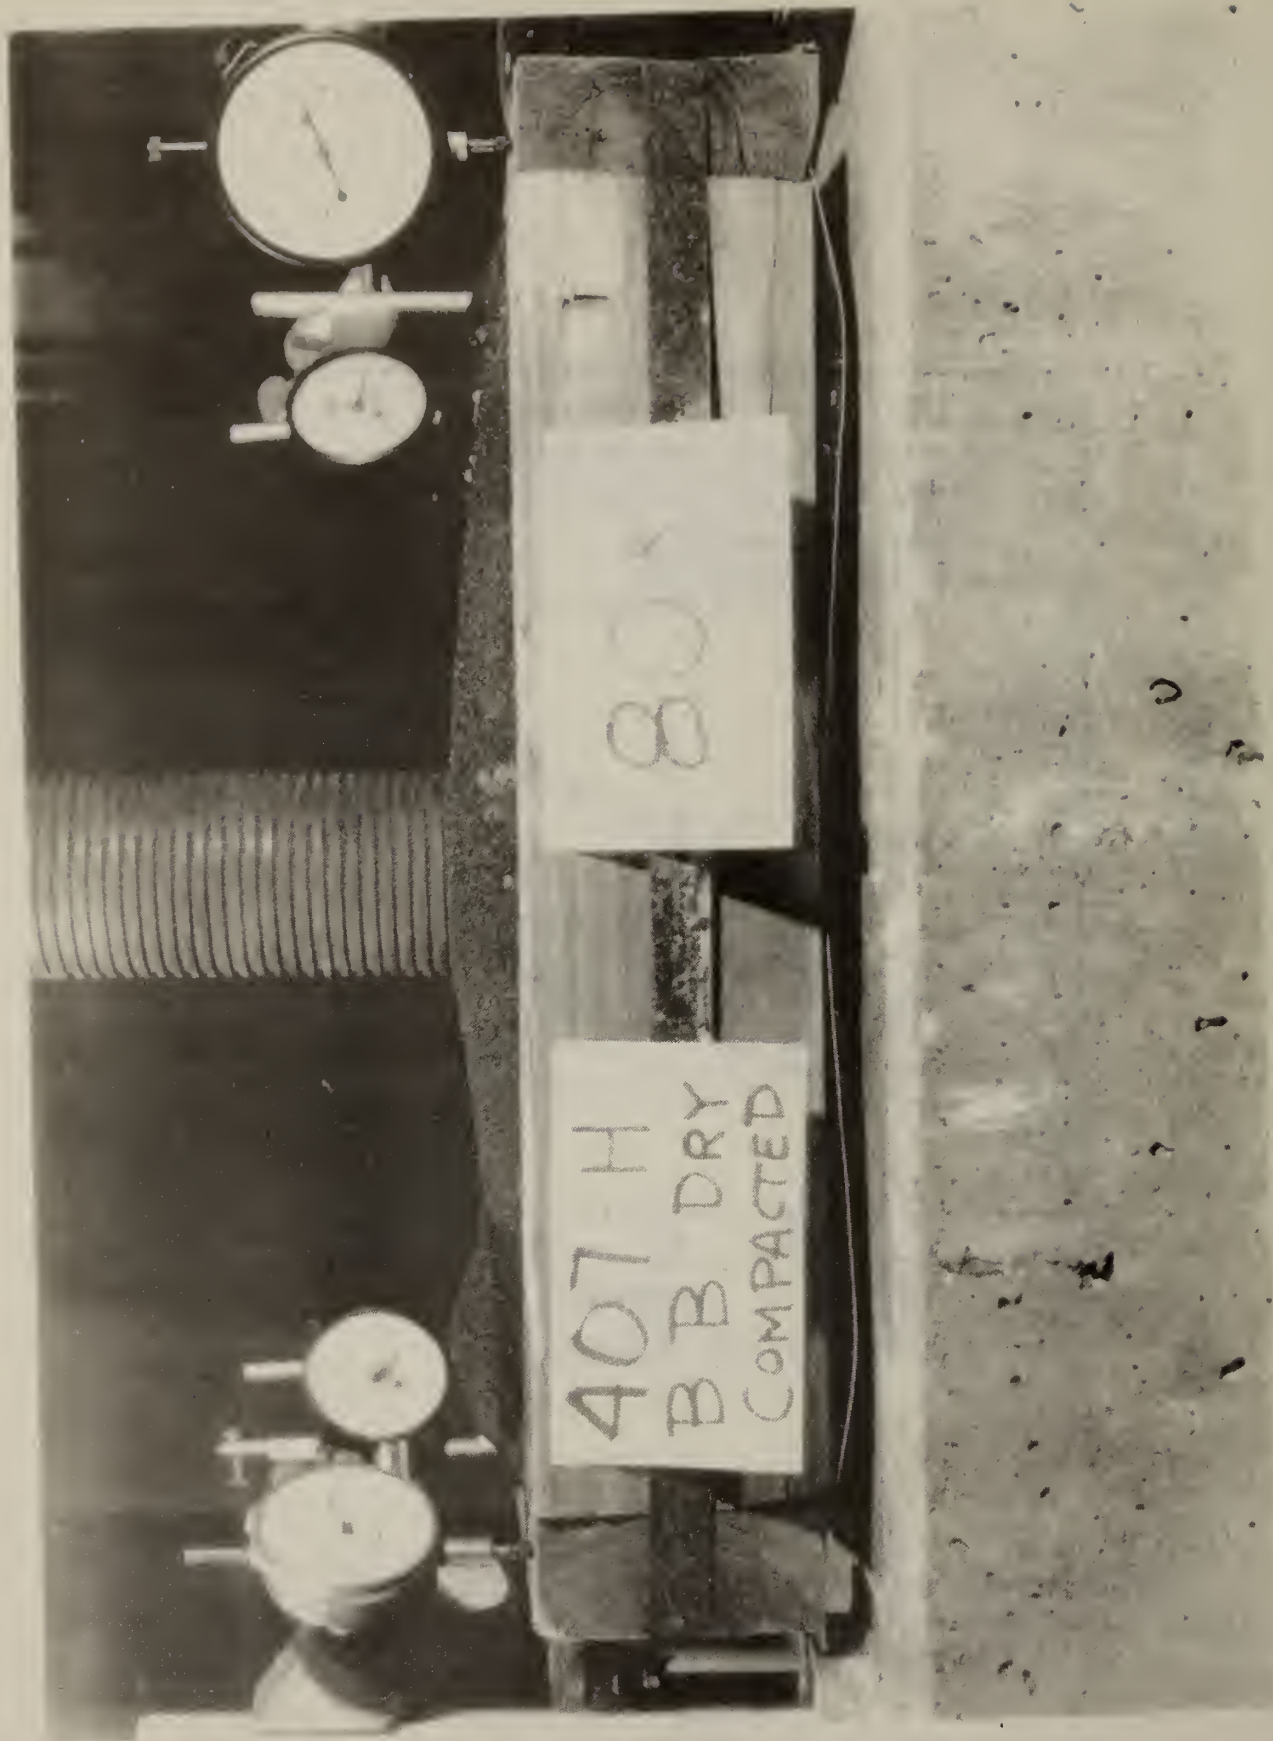
Figure 4.9 Example of uplift of sand box with boiler-slag filler

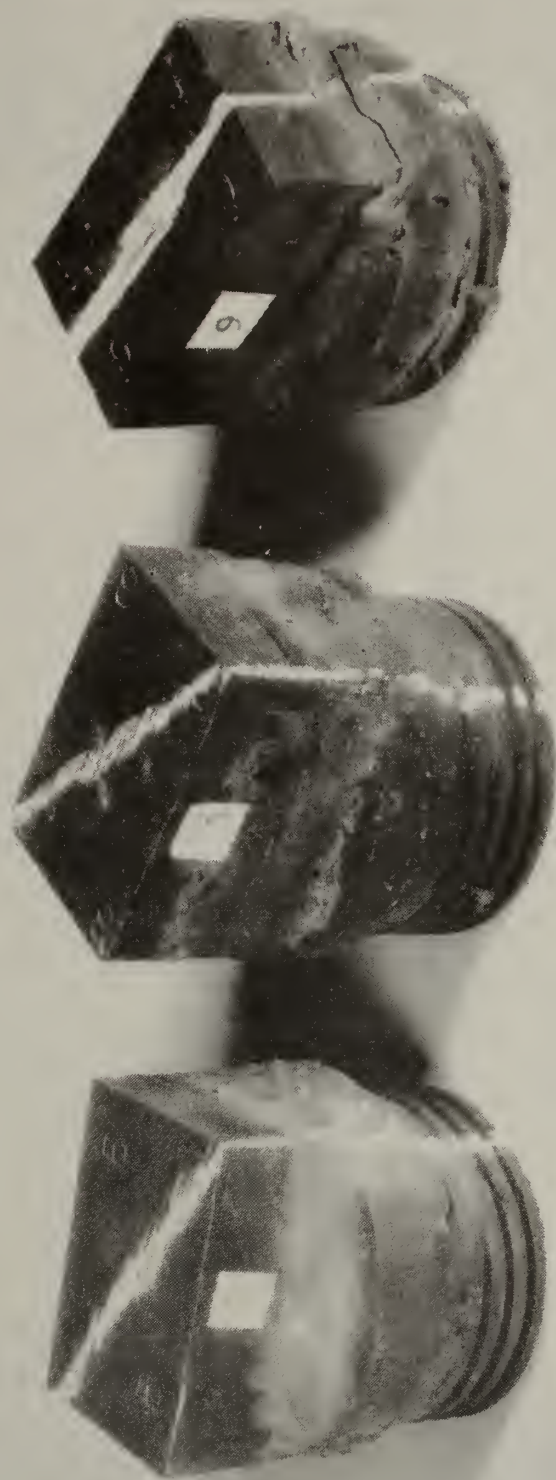
Figure 4.14 Portions of unused screw jacks prior to sectioning

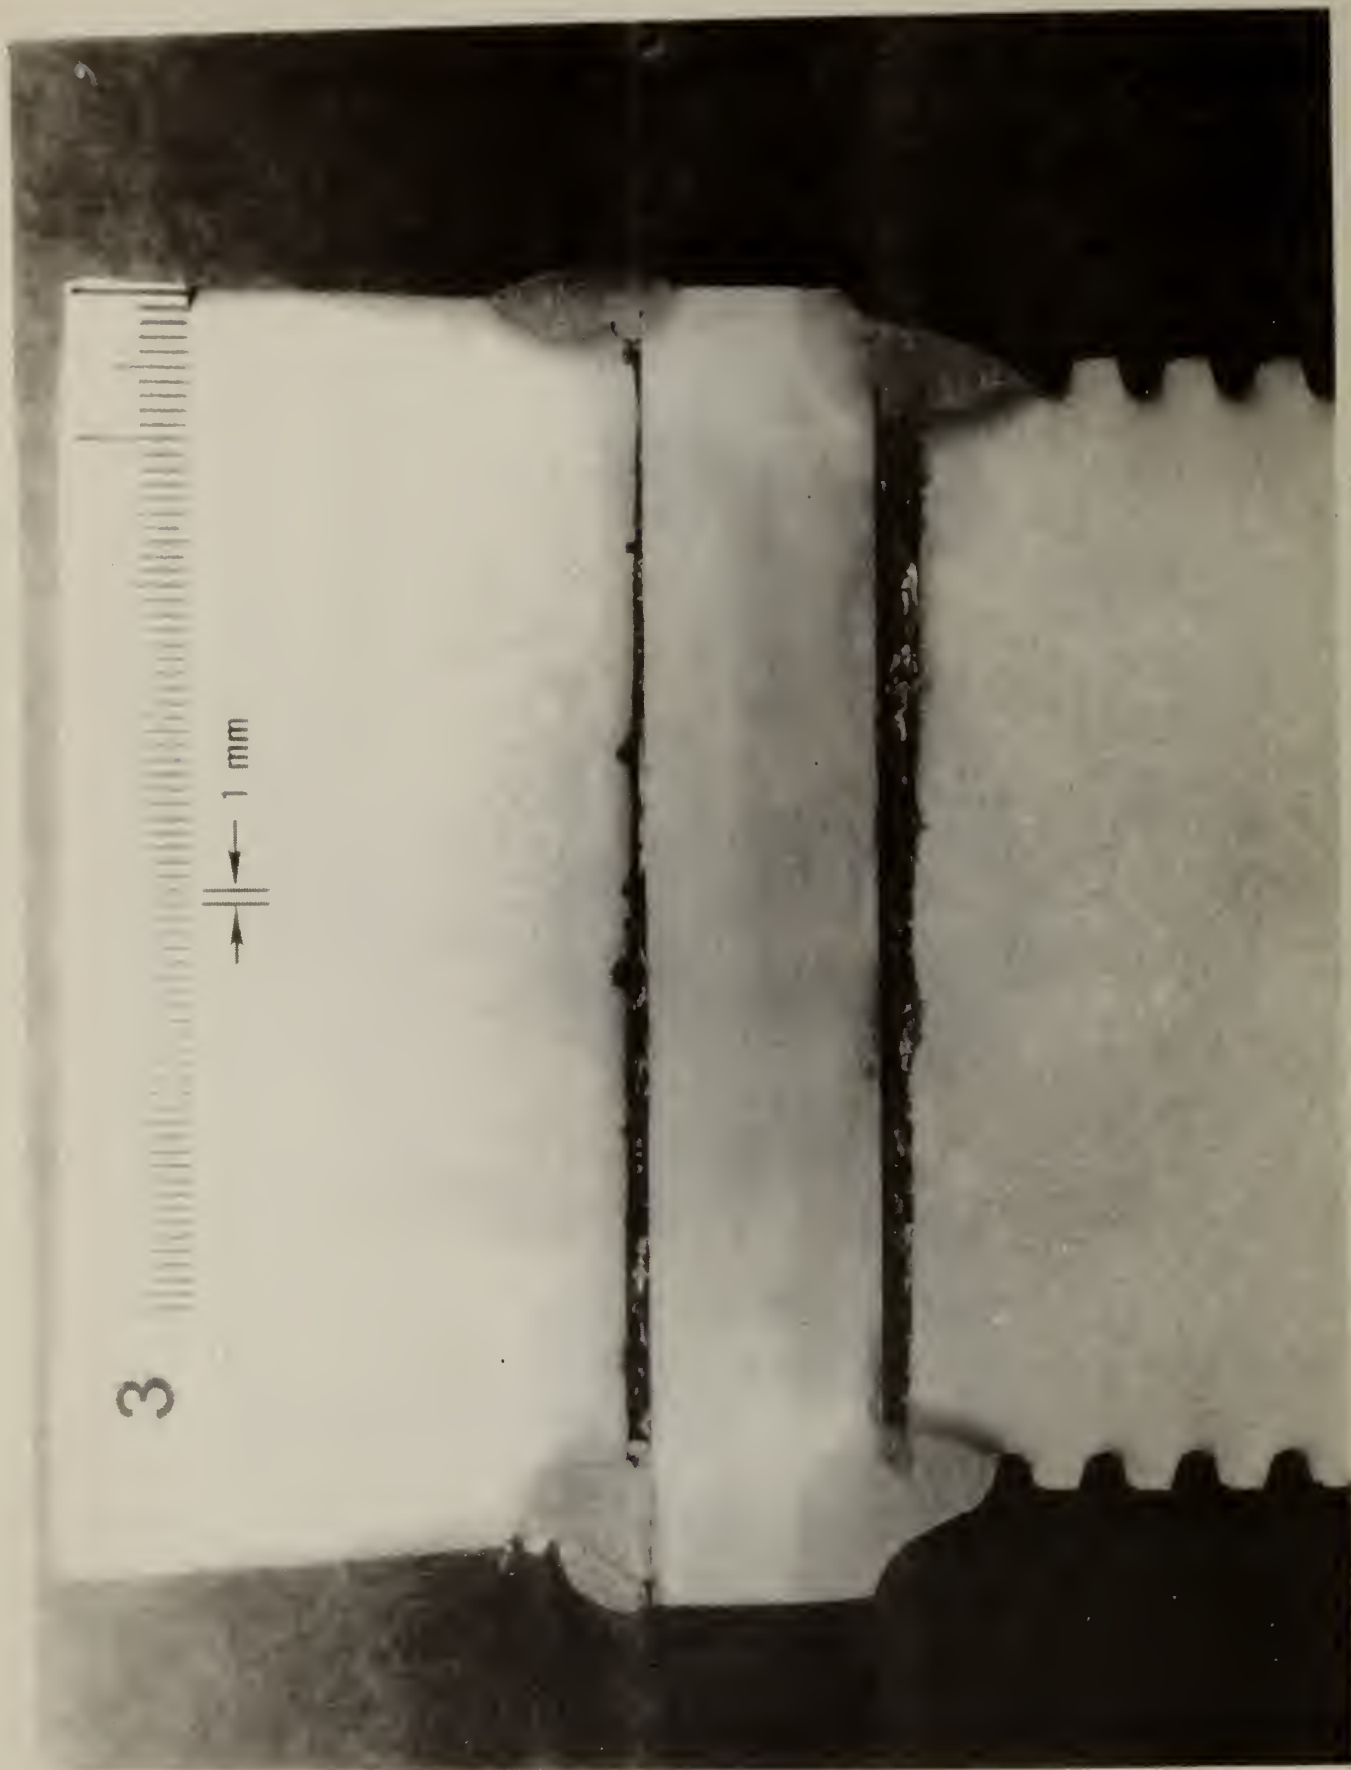
Figure 4.15 Cross-section along diagonal of post of screw jack #3

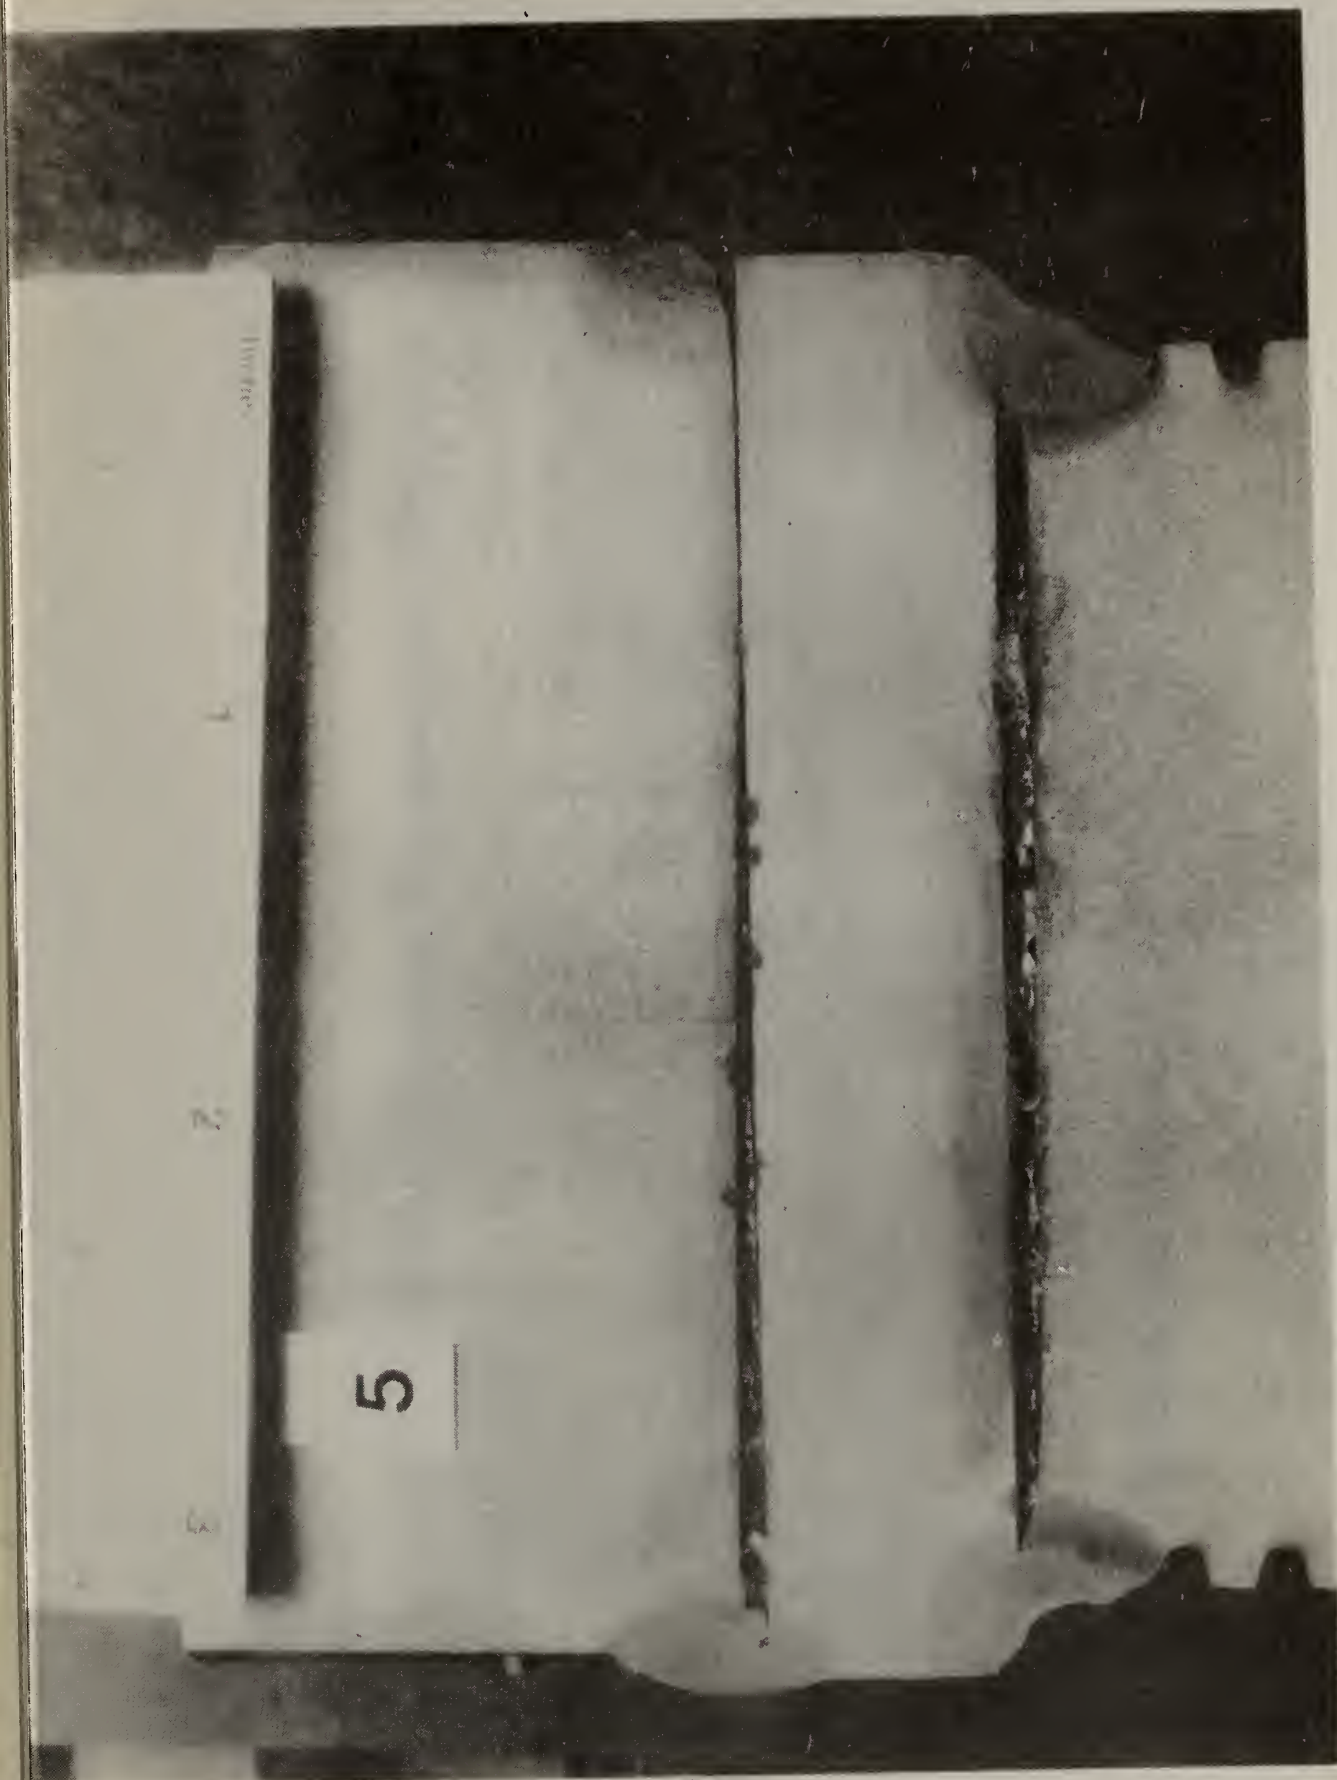
Figure 4.16 Cross-section along diagonal of post of screw jack #5

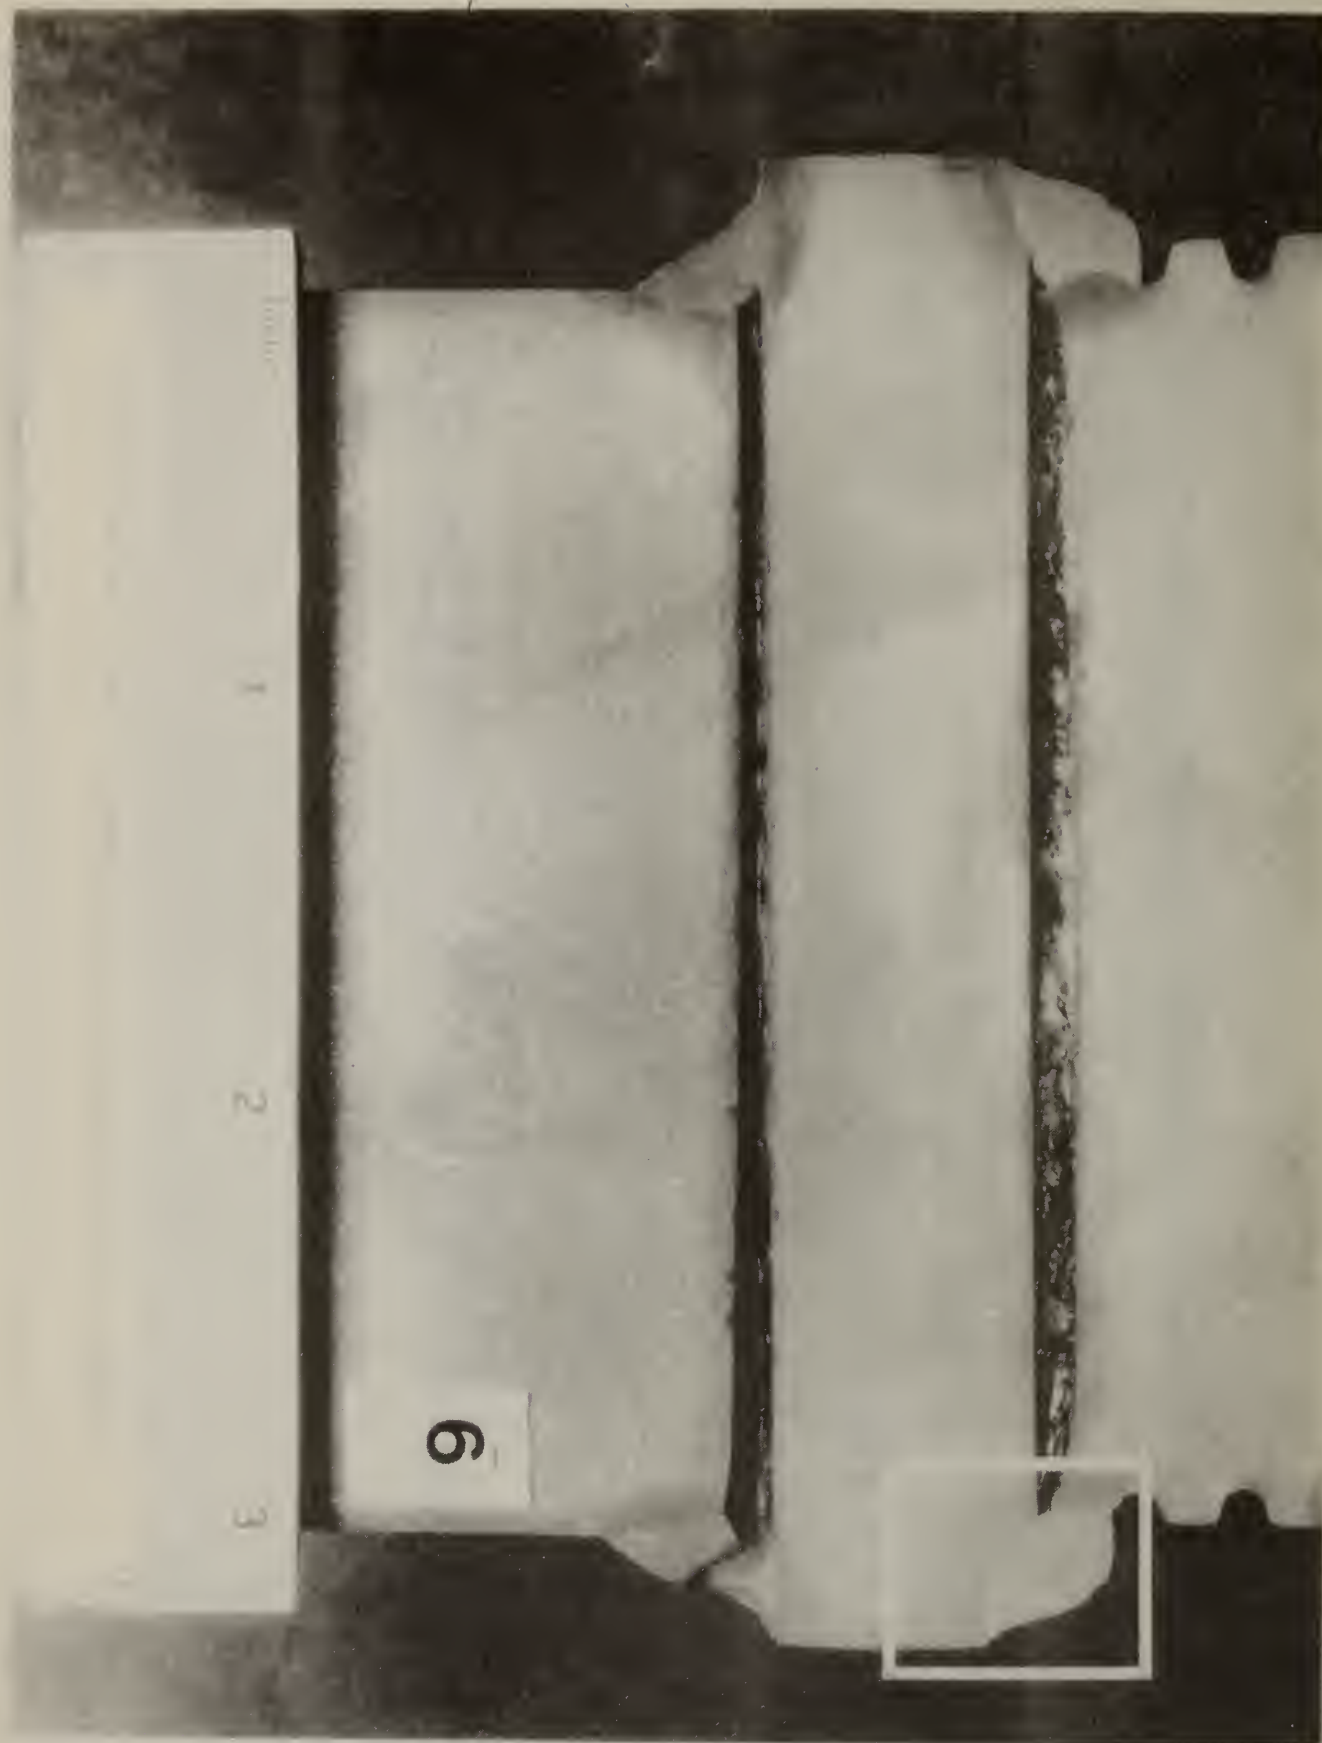
Figure 4.17 Cross-section along width of post of screw jack #9

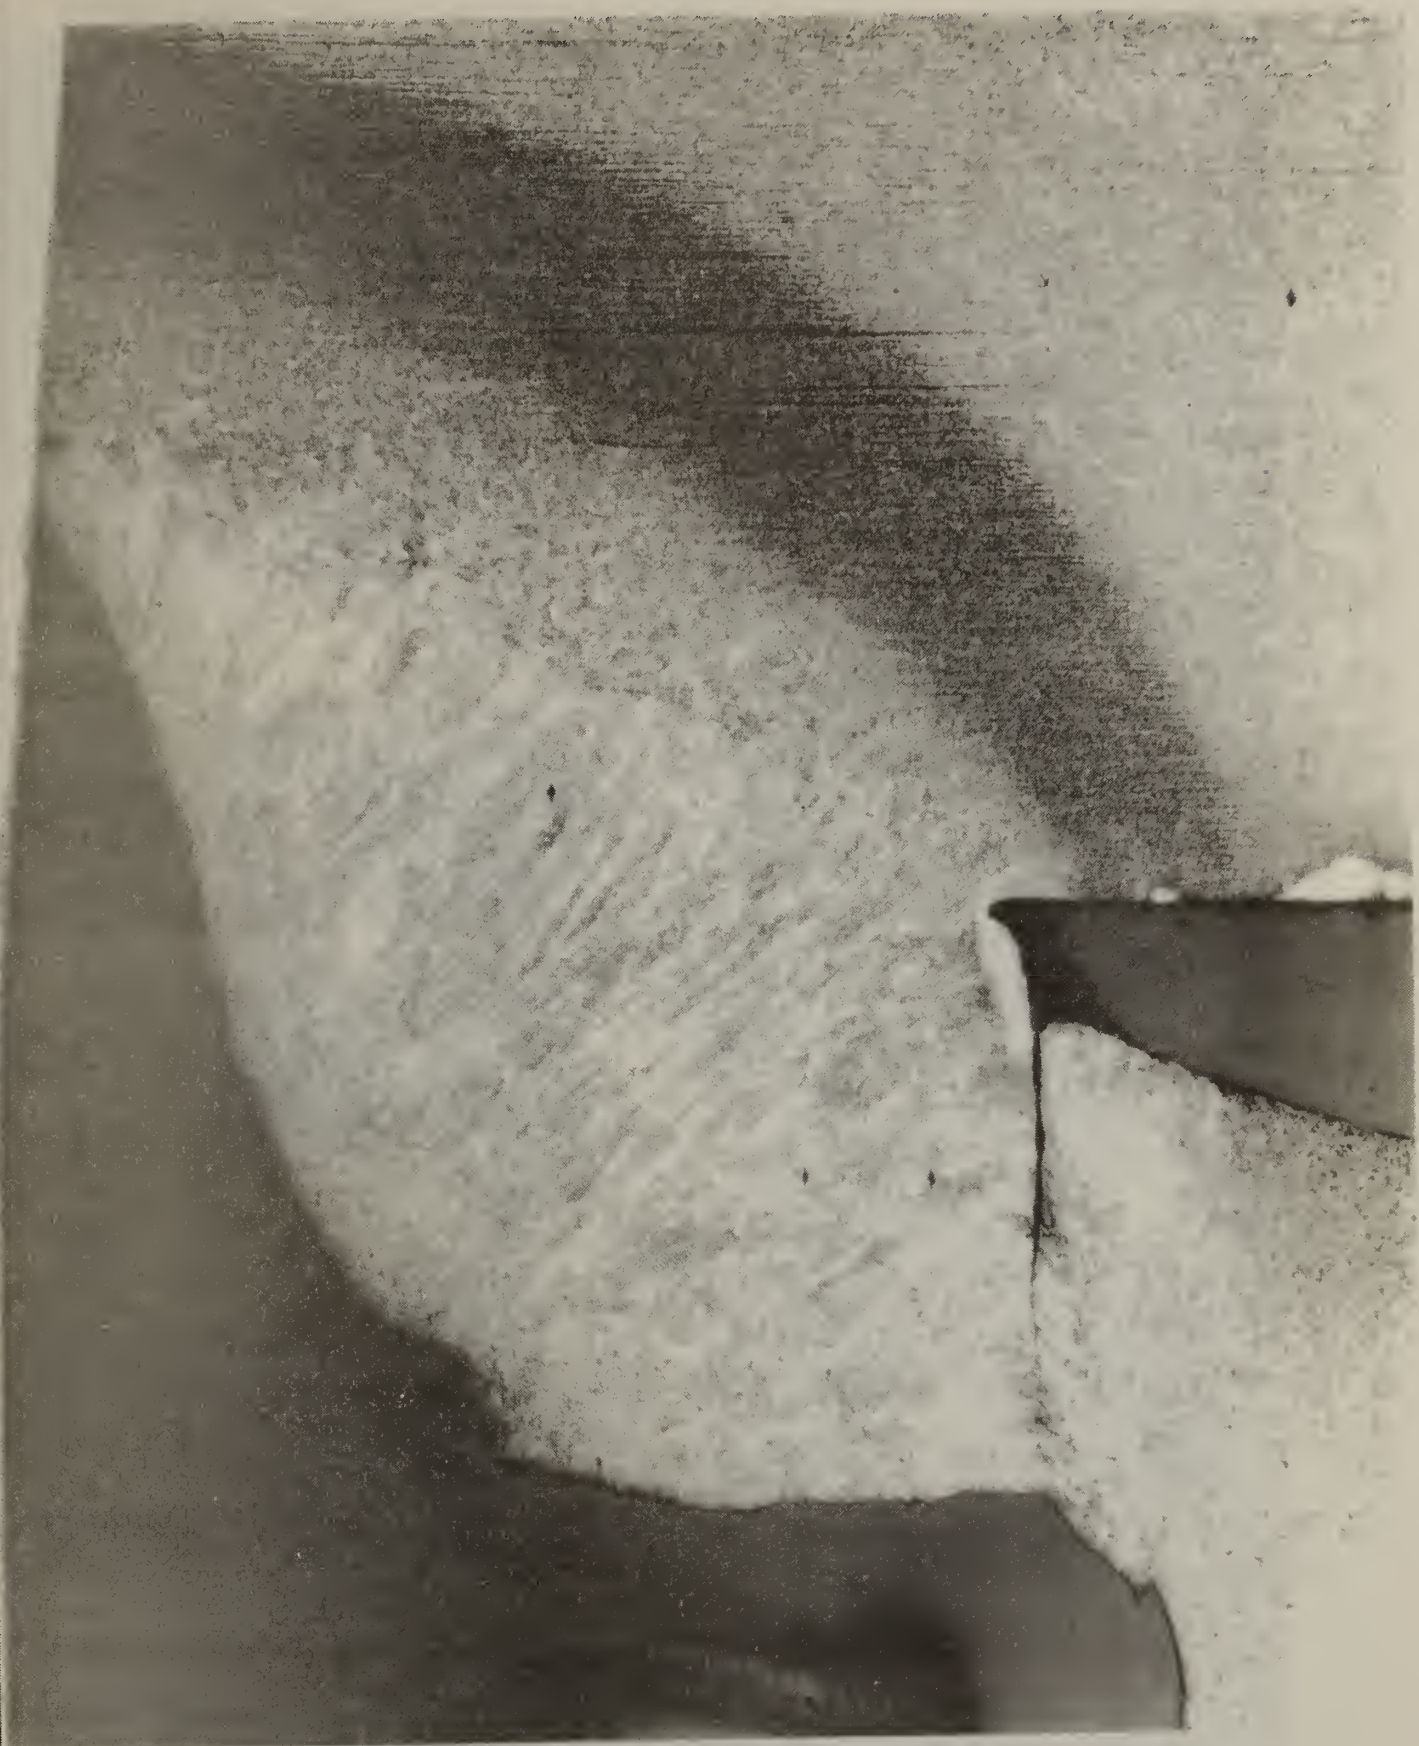
Figure 4.18 Magnified view of area within rectangle in figure 4.17

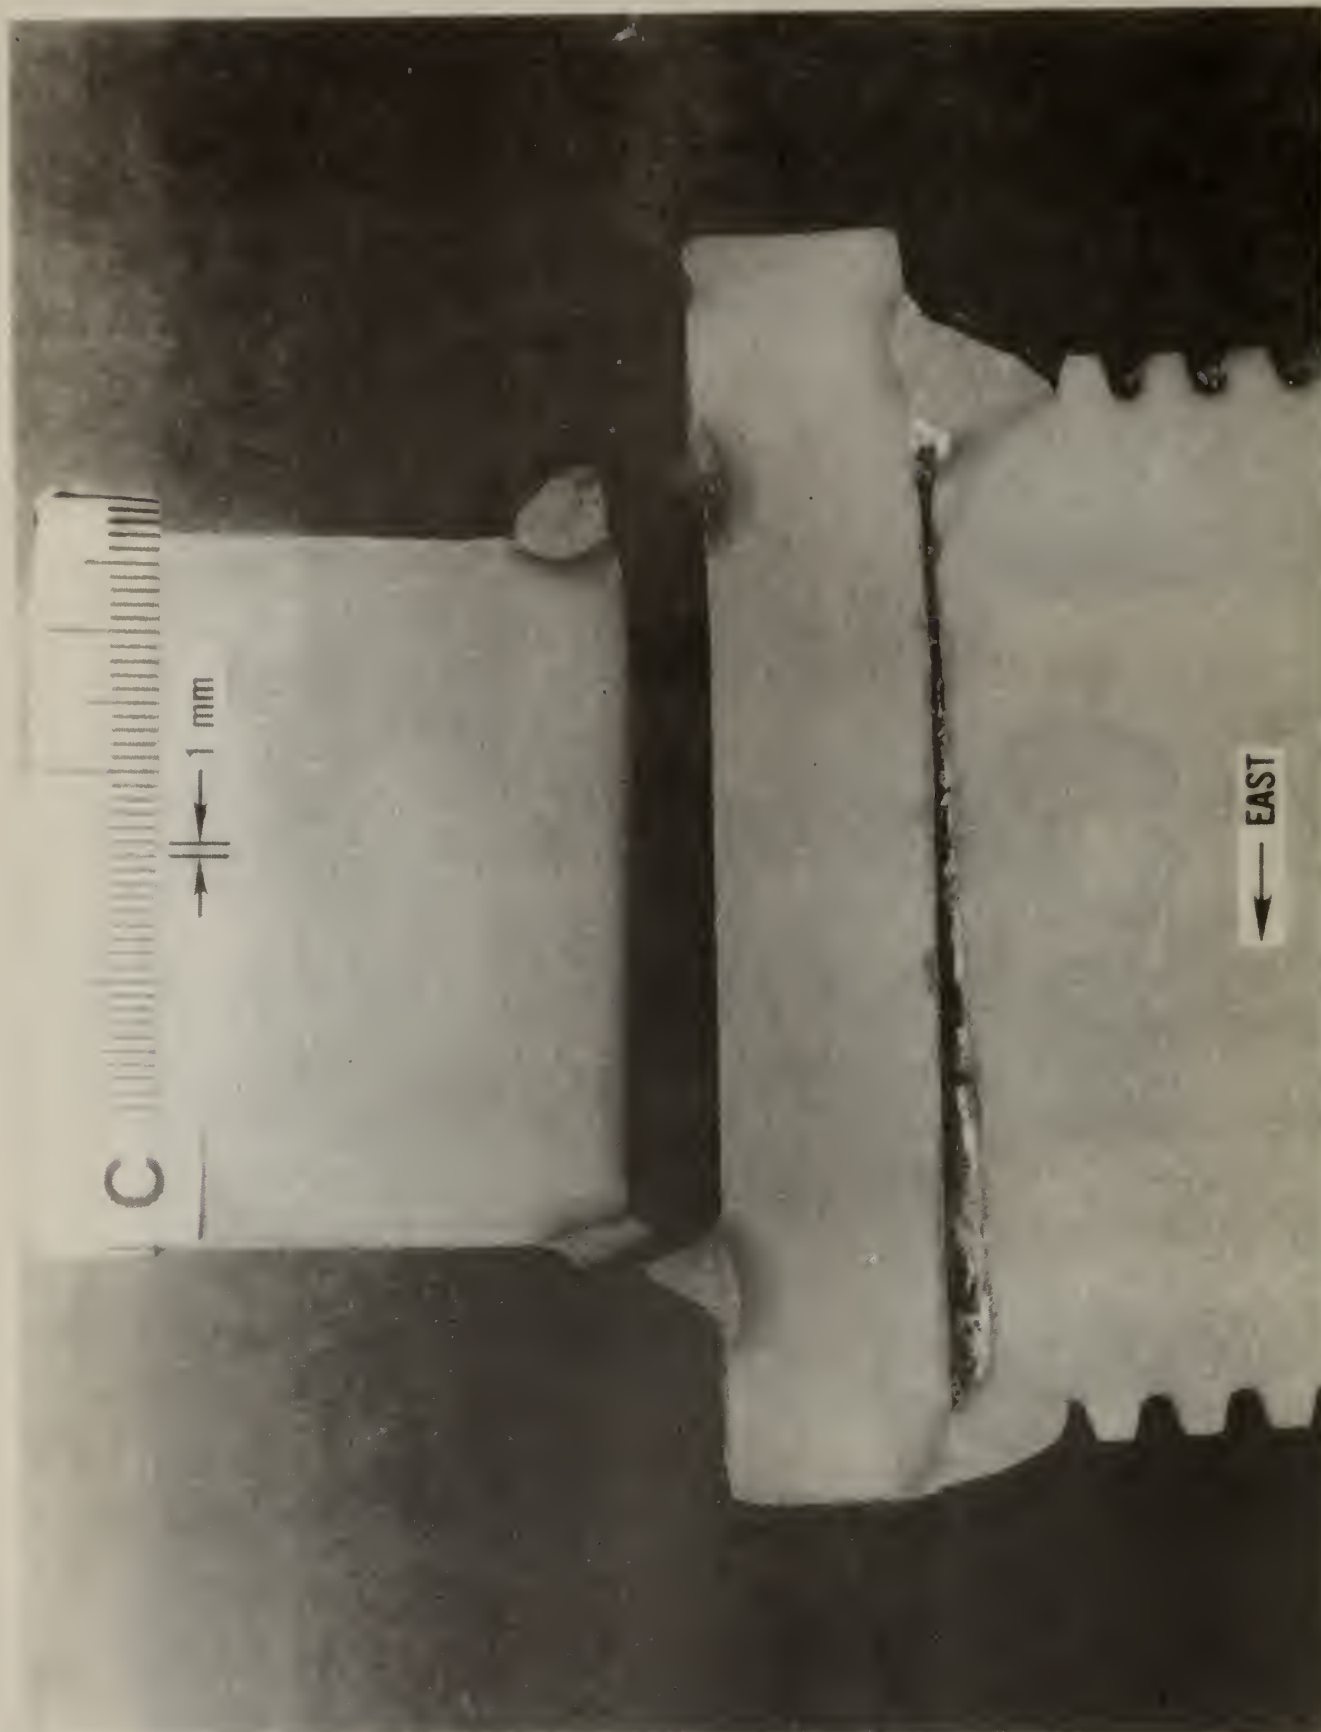
Figure 4.21 Cross-section of screw jack from leg C in tower 407.2(S)

As has been described in section 4.3, the quality of the welds used to fabricate the U-heads at 407.2 was poor and some of them would not have met the minimum weld size requirement in the AWS specification. Therefore, it is possible that the U-heads could have failed if the applied loads produced tensile stresses on the screw jack. A finite element analysis of the crossbeam was performed in which the translations of the tops of the towers at 407.2 were introduced as relative displacements between the top and bottom flanges. The results showed that bending moments would have developed at the U-heads which produce tensile stresses on the east side of the screw jacks. Appendix C describes the finite element model used for this analysis and presents the resulting deflected shapes of the crossbeam. Figure 4.21 clearly shows that the weld on the east side of the rectangular block fractured. Figures 4.20 and 4.21 reveal compressive yielding on the west side of screw jacks B and C, which indicates the direction of failure of the top of the U-heads. This mode of failure is consistent with the analytical prediction. Figure 6.8 is presented as further evidence to confirm this behavior. The photograph shows the U-head at leg D of the south tower at pier 406. It is evident that the top of the U-head is bent toward the west. Failure probably did not occur in this case because the weld quality was sufficient to resist the tensile stresses.
